## Mainland Enhancement of Salmonoid Species Society

M.E.S.S.S. Report - Rotation 5  
 DFO Area 12 Stock Assessment 2024

Enumeration Period: September 27 - October 3, 2024

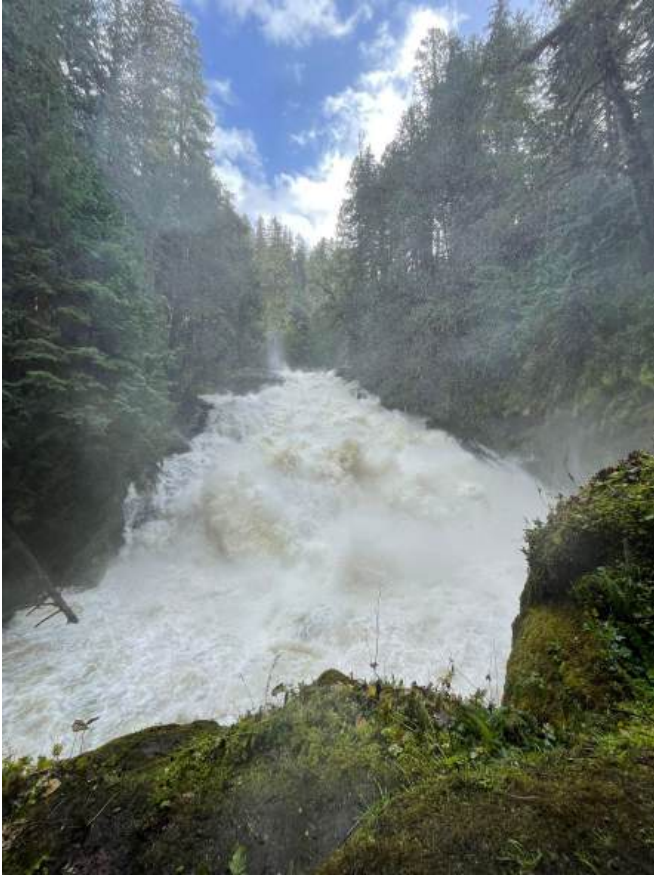
Photo 1.1 – Rushing waterfall at Hada River.

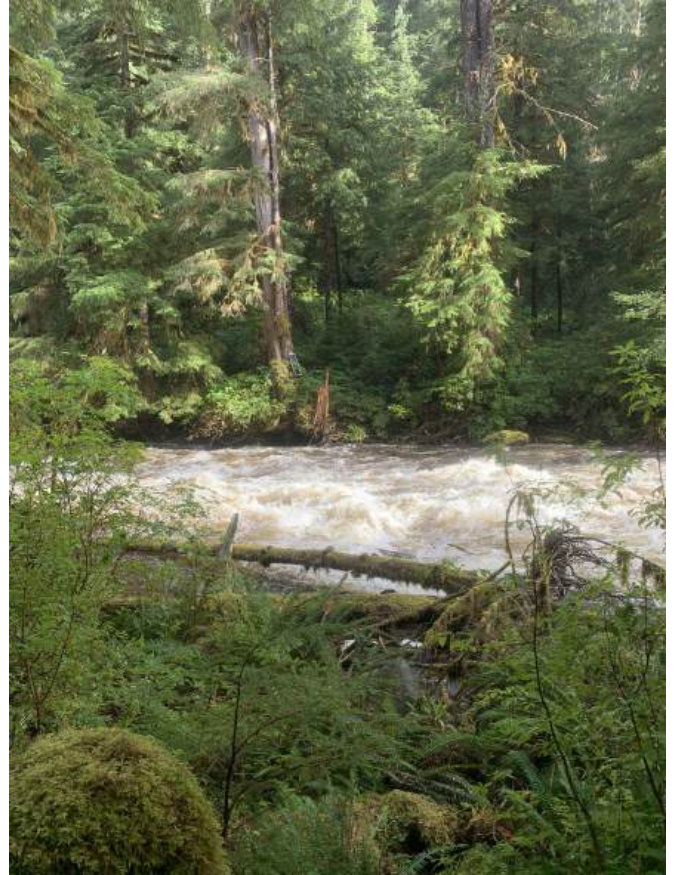
Photo 1.2 - High flows in the rock garden below the Hada falls.

- Stream flooding to bankful, unsurveyable conditions.
- Spawned out fish seen holding in the stream margins.

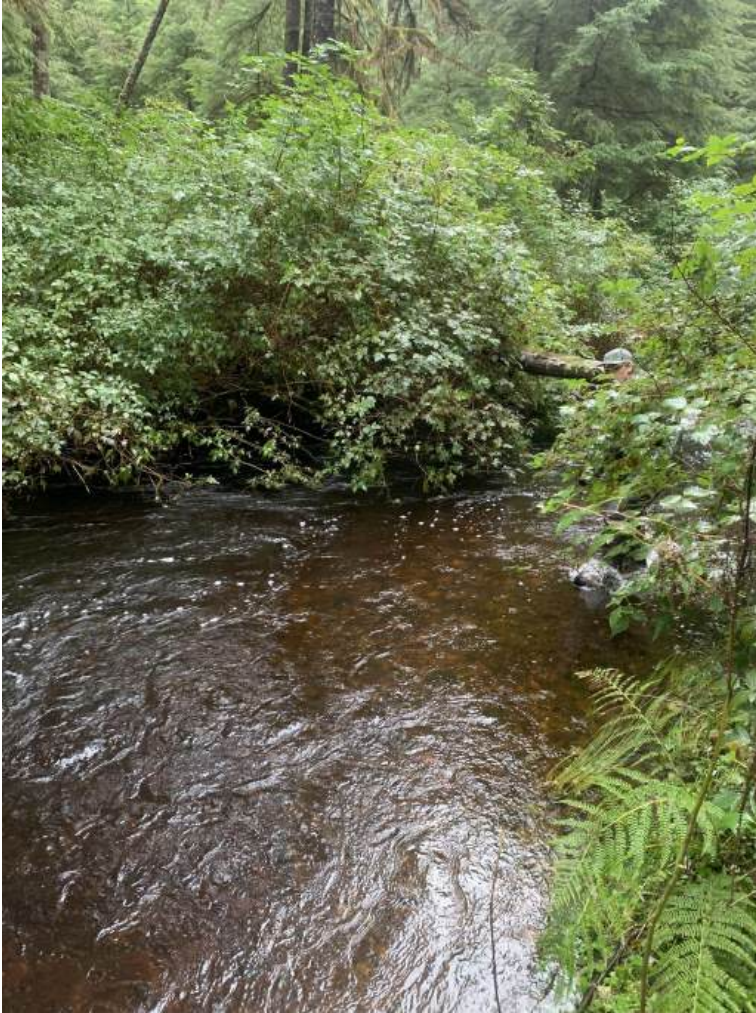
Photo 2 - High water in Wahkana creek, running just below the vegetation line.

- High flows made for poor surveying conditions. 100% bankful flow.
- Bank walked with two pinks seen spawning in a low gradient section.

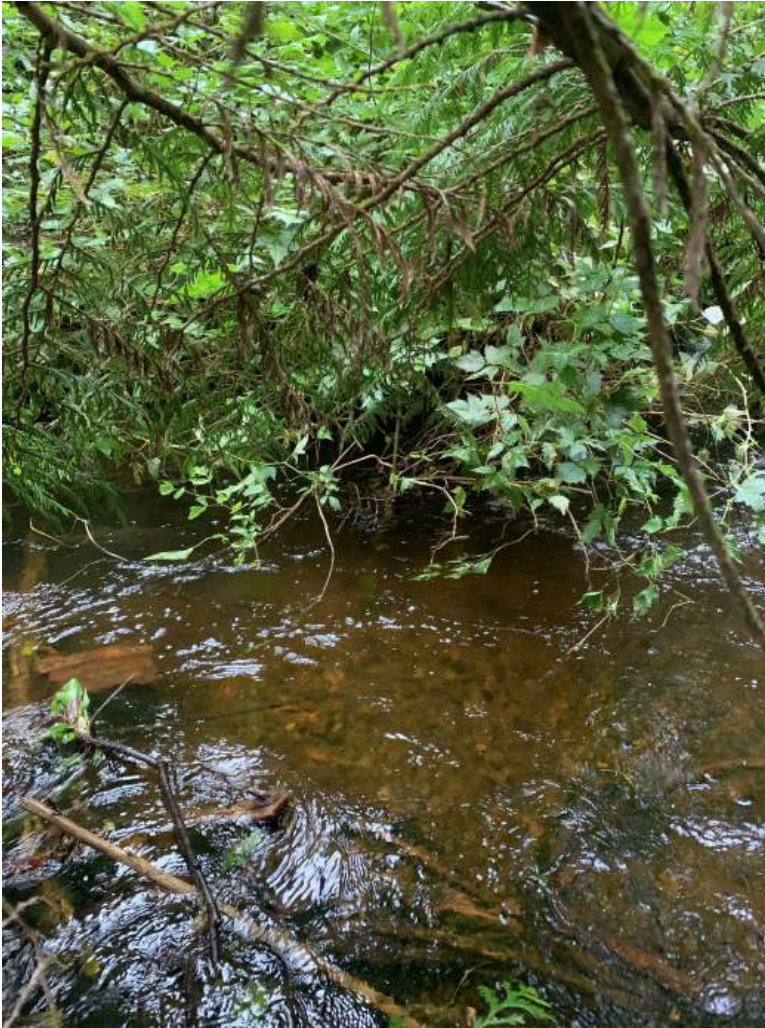
Photo 4 – The substrate where pinks were spawning in Carriden Bay Creek.

- Fish seen paired up and spawning on the little available spawning substrate.
- Spawners observed 300m up from tidal influence.

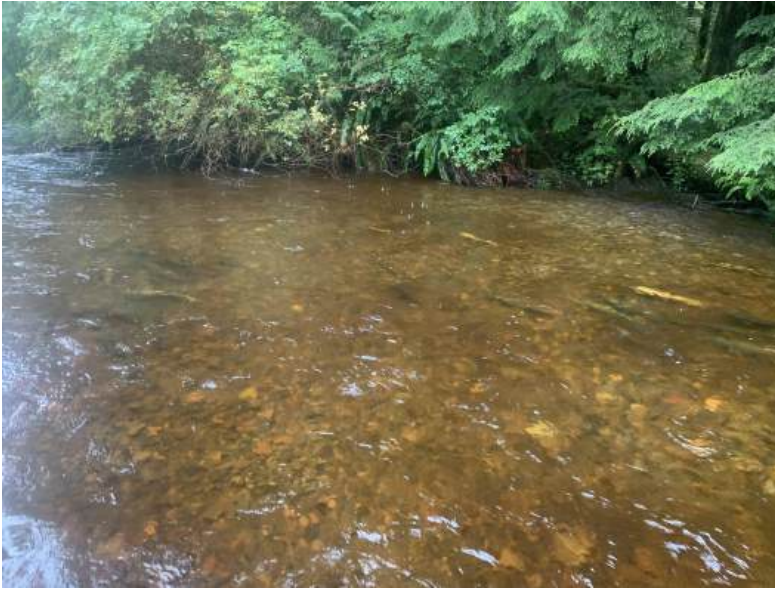
Photo 5 – Chum salmon spawning in Viner River.

- Only one segment (approx half the system) surveyed due to high flows and safety concerns.
- Majority of chum seen paired up on redds.

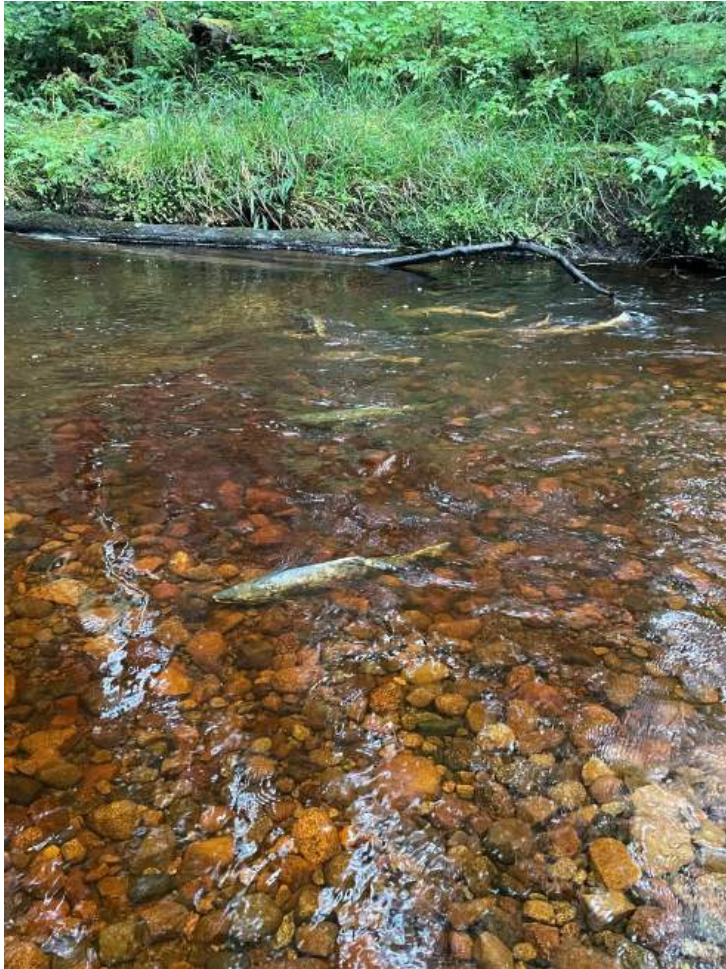
Photo 6- Chum in Shoal Harbour Creek.

- Large increase in chum spawning in second segment
- Chum seen spawning in third segment and 50m up Mt Worthington creek.

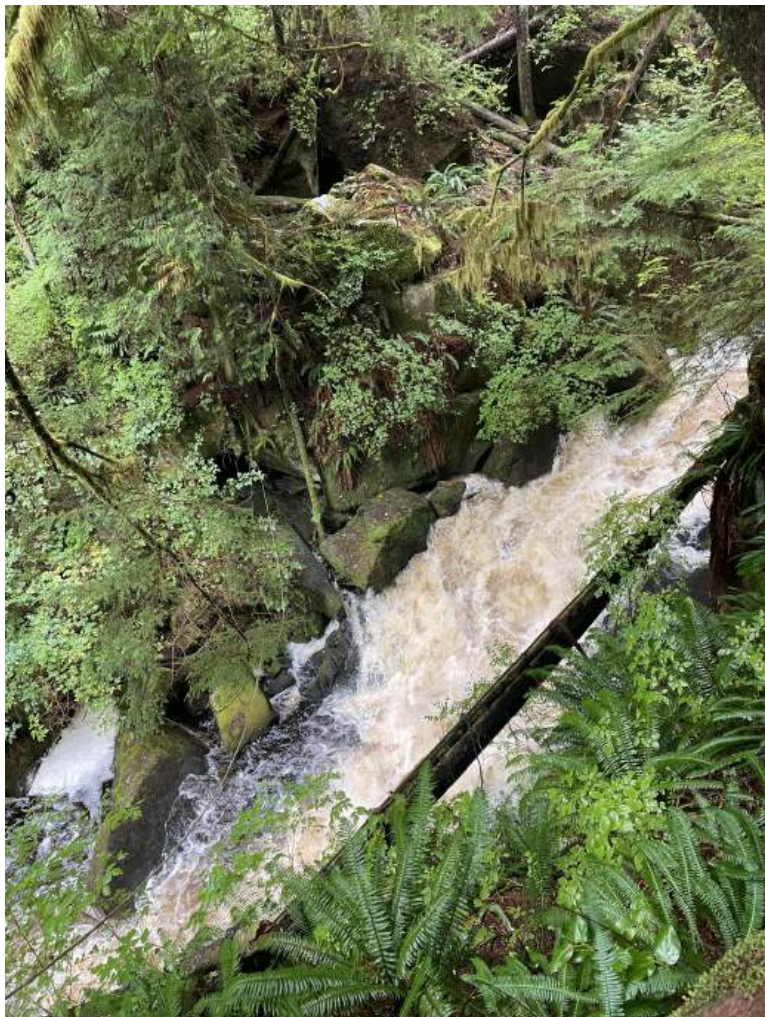
Photo 7– High water flow in Scott Cove Creek.

- 21 coho and 10 jacks observed jumping between both falls.
- Very high flows due to a rainstorm occurring the previous night.
- Fish observed attempting to jump the falls and staging below.
- The falls jumper count is more of a presence absence survey than a population estimate.

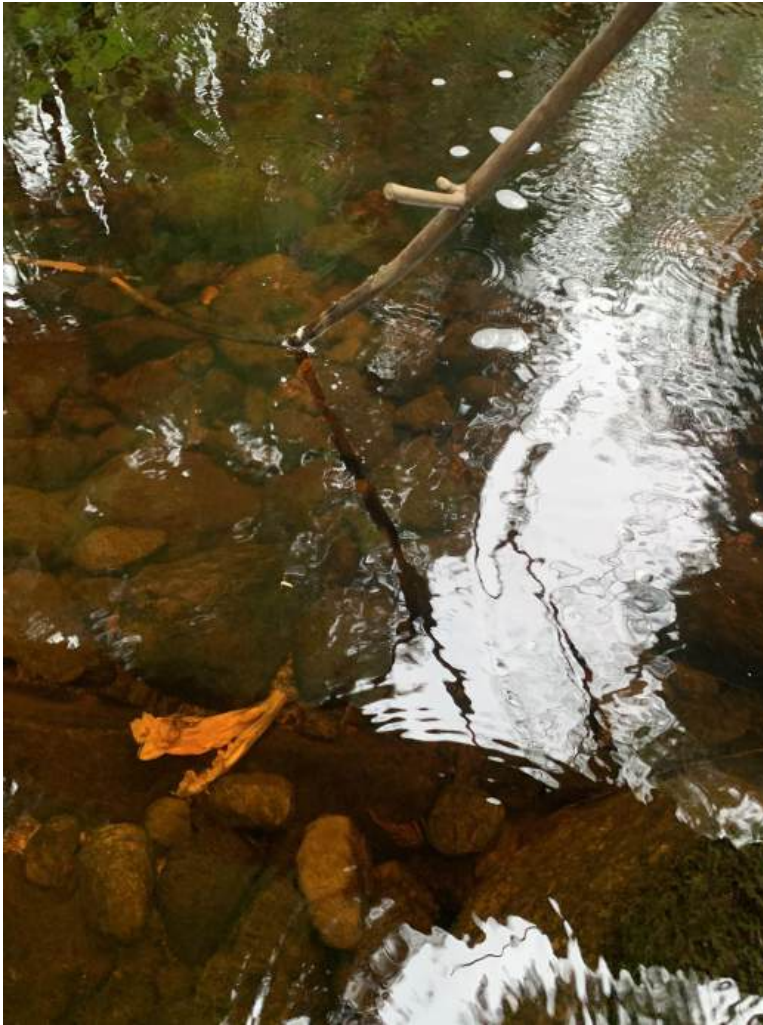
Photo 8 - A pink salmon lower jawbone found in Maple Cove creek, near where fish were spawning last survey.

- Pinks observed spawning throughout the first segment.
- 12 redds in first segment, potentially spawned on between surveys.
- No redds seen in second segment.

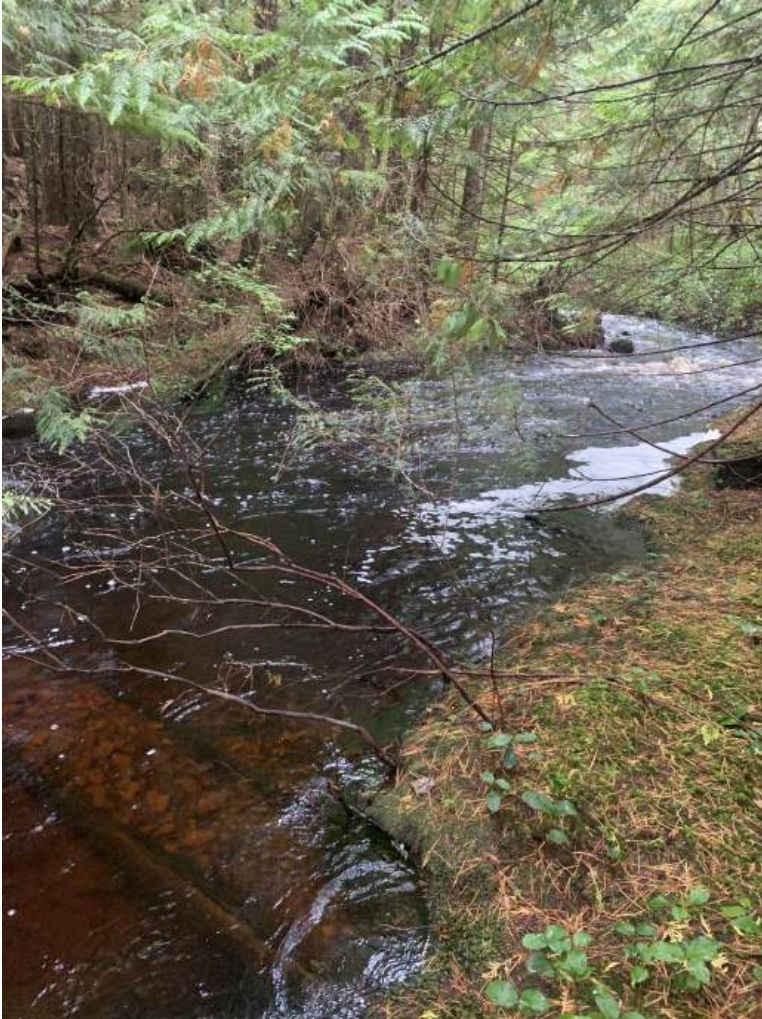
Photo 9 - Minihump creek at the bend where flows increase and substrate turns from small gravel to larger gravel.

- No minihump or coho salmon seen in the stream.
- High flow and tannic water made for very poor surveying conditions. Approximately 15% of stream confidently surveyed.
- No sign of great blue herons or mergansers, the most common predators of minihump salmon.

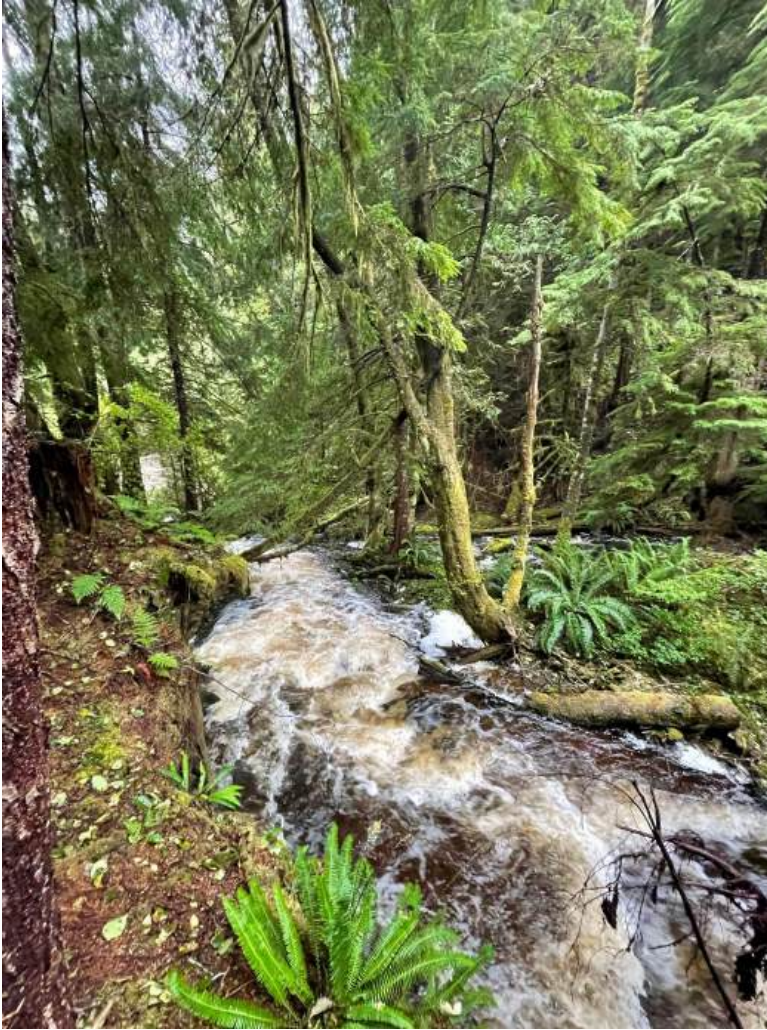
Photo 9 - High flows in Simoom Sound Creek near the estuary.

- Stream unsurveyable due to high water. Bank walked to the first tributary.
