Mainland Enhancement of Salmonoid Species Society

M.E.S.S.S. Report - Rotation 6
DFO Area 12 Stock Assessment 2023

Enumeration Period: October 13-19, 2023

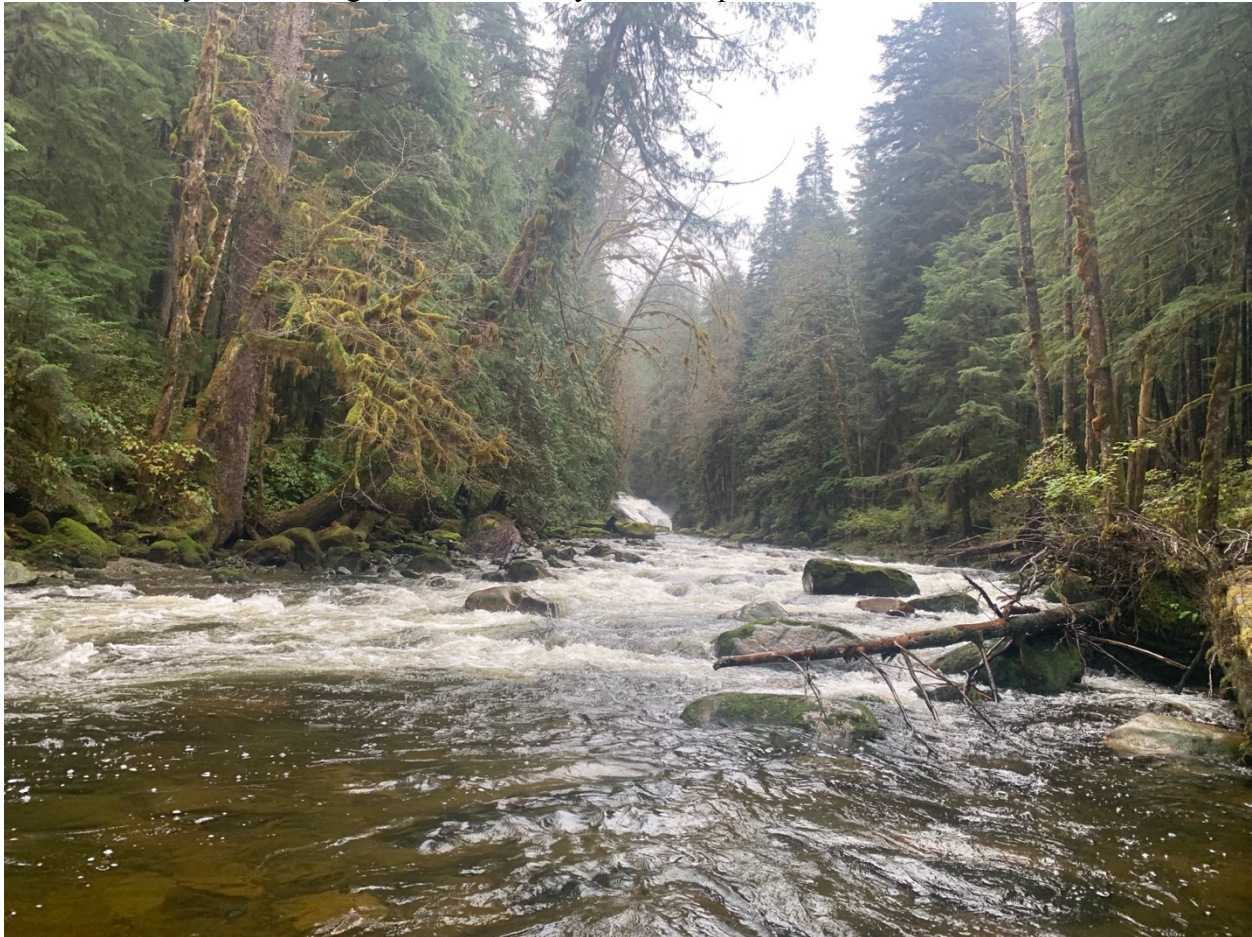
Photo 1 – Water levels in the upper segment of Ahta. Waterfall seen in background.

- High flows due to rain flushing post spawn fish out.
 - Large decrease in bear activity and sign.
 - Coho seen rolling in pools and runs.
 - Chum spawning in side channels and other features out of the main flow.
-

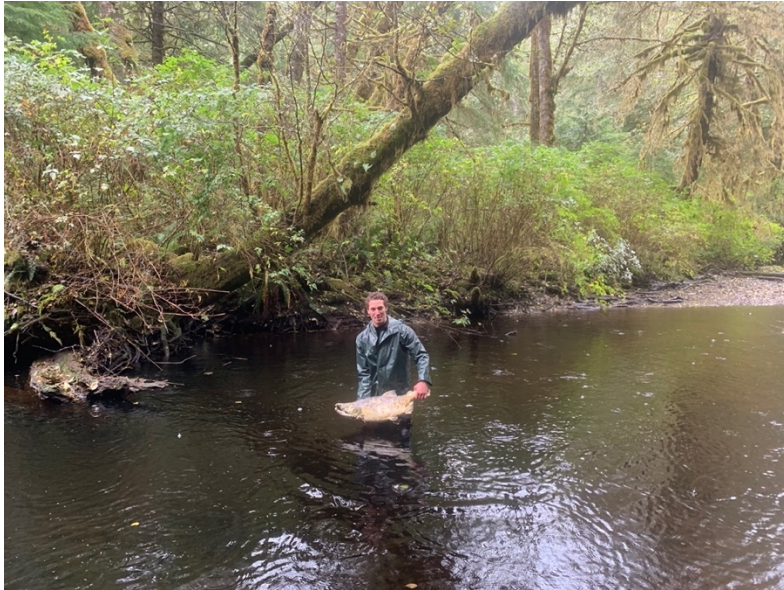
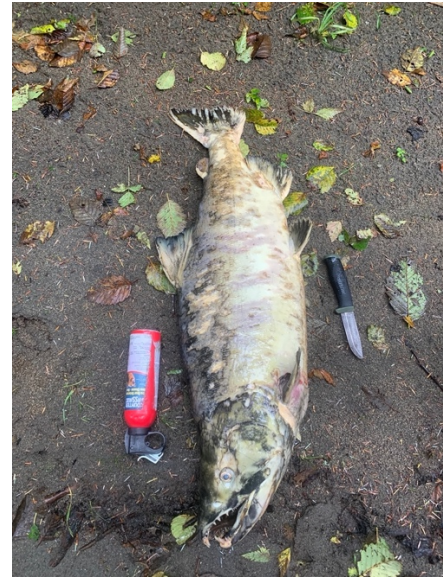
Photo 2 – The large spawned out male chum found in segment 1.

- Chums seen spawning in small groups in the first segment.
 - Large spawned out male encountered in first segment.
 - Drop in visibility throughout second segment due to flow and alder leaves in pools.
-

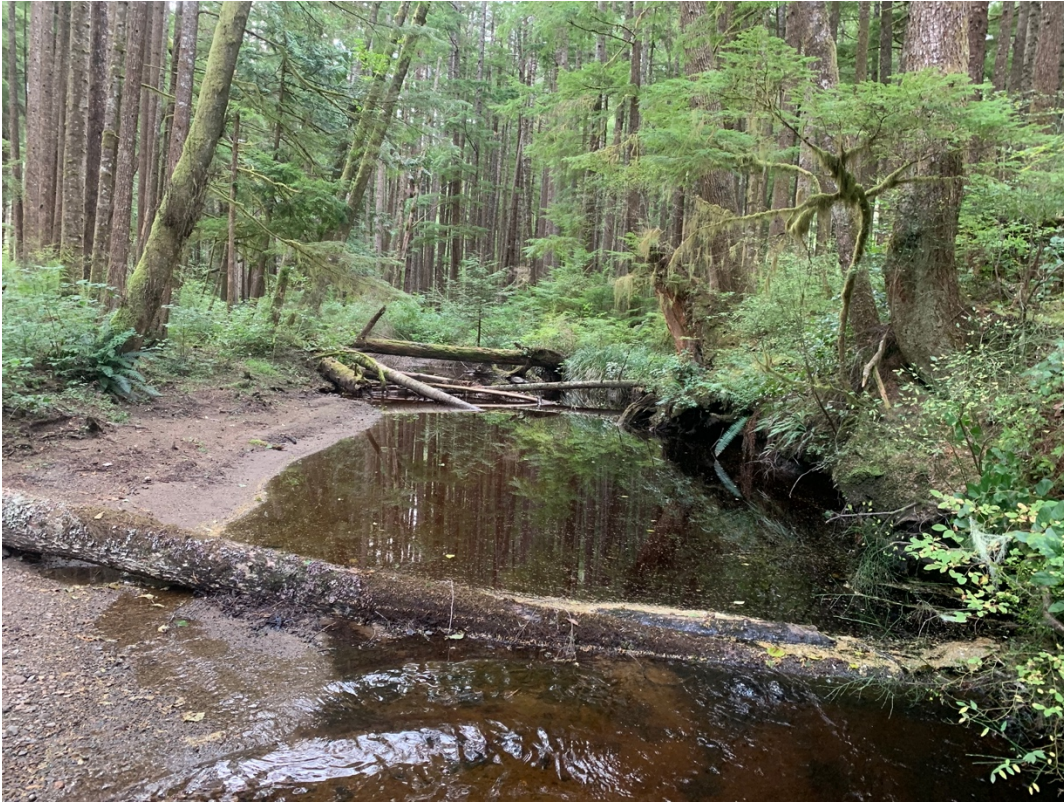
Photo 3- Water levels in the second segment of Shoal Harbour Creek.

- Small increase in flows.
 - Little sign of spawning fish other than carcasses.
-

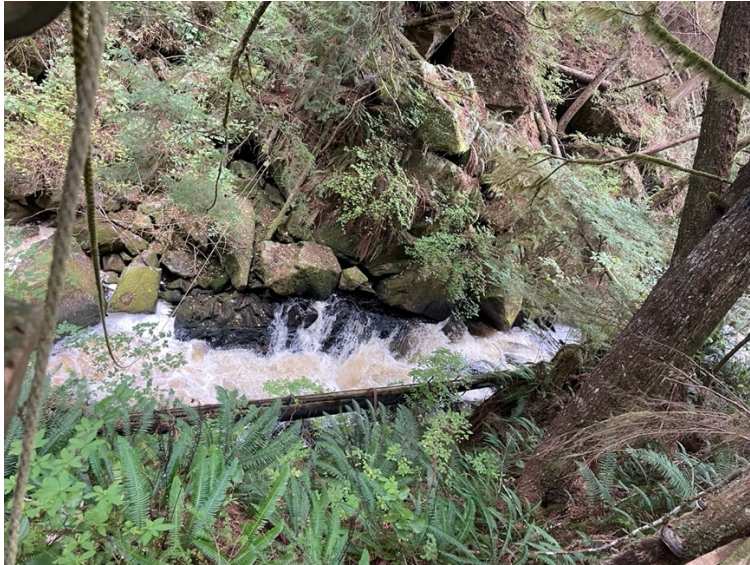
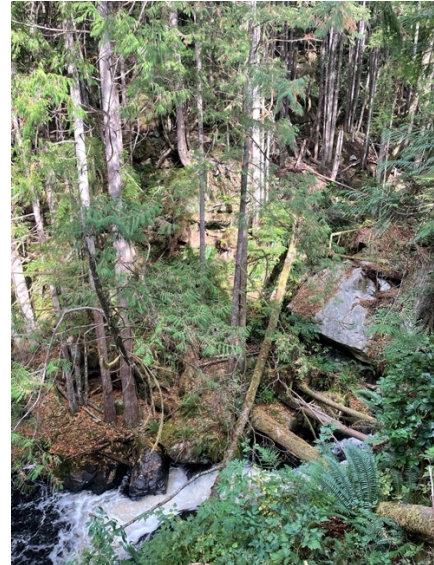
Photo 4 – Water levels at the both falls on Scott Cove creek, same location where 20 min jumper survey occurs. Lower falls on left, upper falls on the right.

-Decreased levels of activity at both falls. More activity at lower falls than upper set.

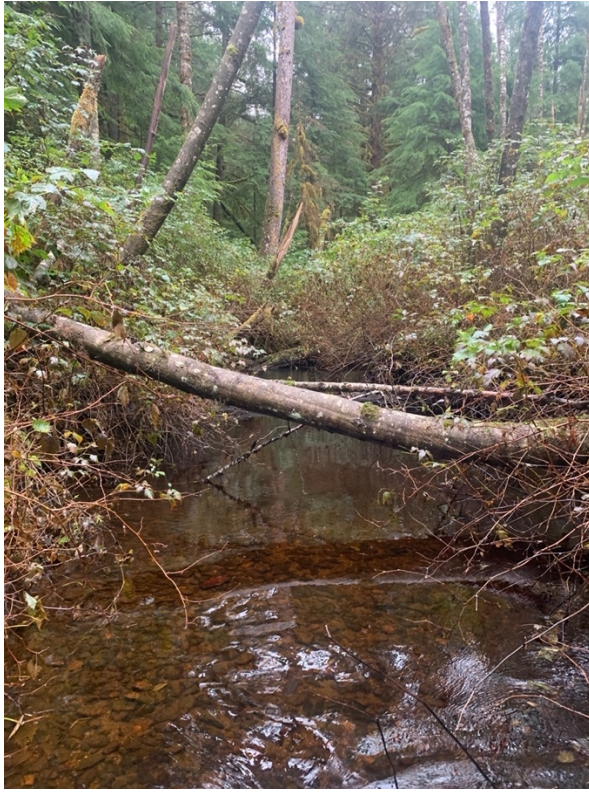
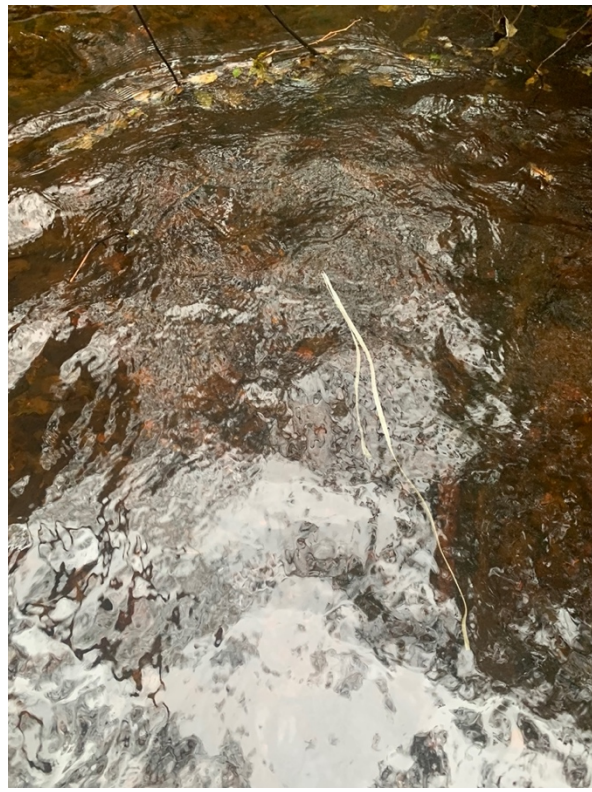
Photo 5— Flow and visibility in main portion of Wahkana on the left, small tape worm found instream to the right.

- Increased water levels, better visibility than previous surveys.
 - Both segments surveyed for coho and chum moving through the creek.
 - Fresh bear sign (scat + tapeworms), first sign of bears in watershed.
-

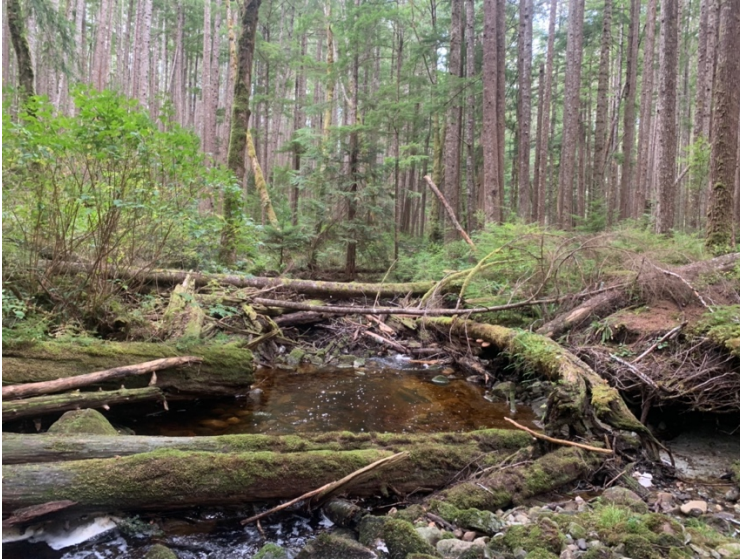
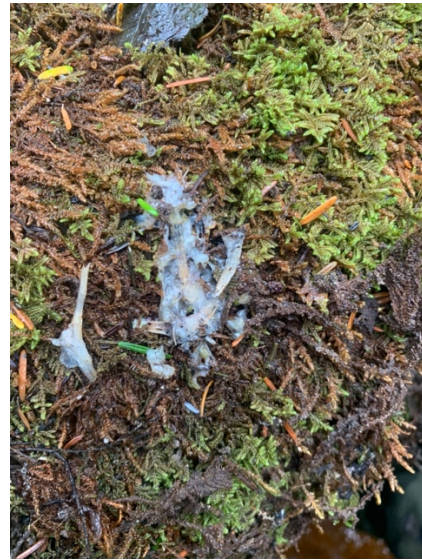
Photo 6 – Water flow through the lower logjam, partially digested fish fins.

- No fish seen.
 - Digested fish fins found in a scat on a log.
 - Good observer efficiency in both segments.
-

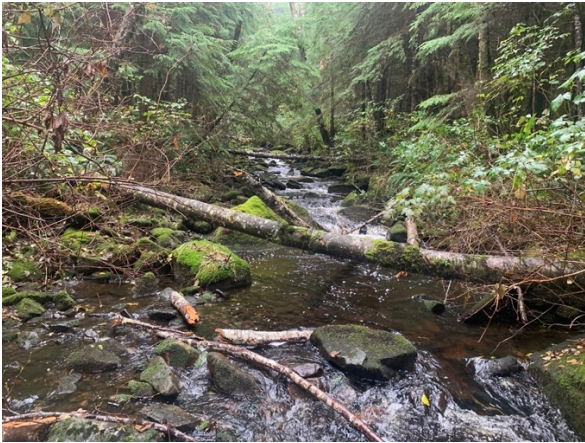
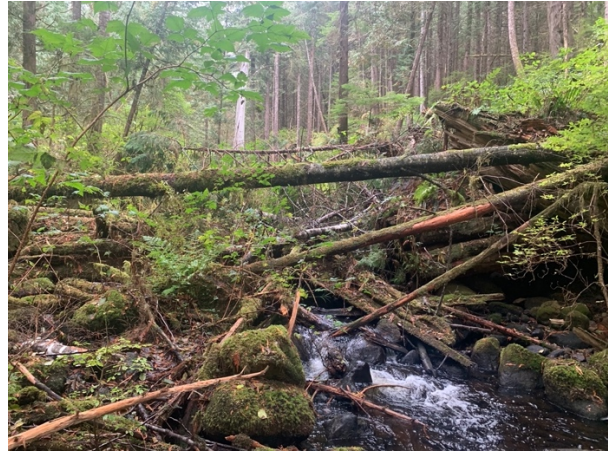
Photo 7 – Bankful flows in the lower part of Carriden creek. Fresh windthrow along the first segment.

-Increased flow due to recent rains.

-River flowing at bankful.

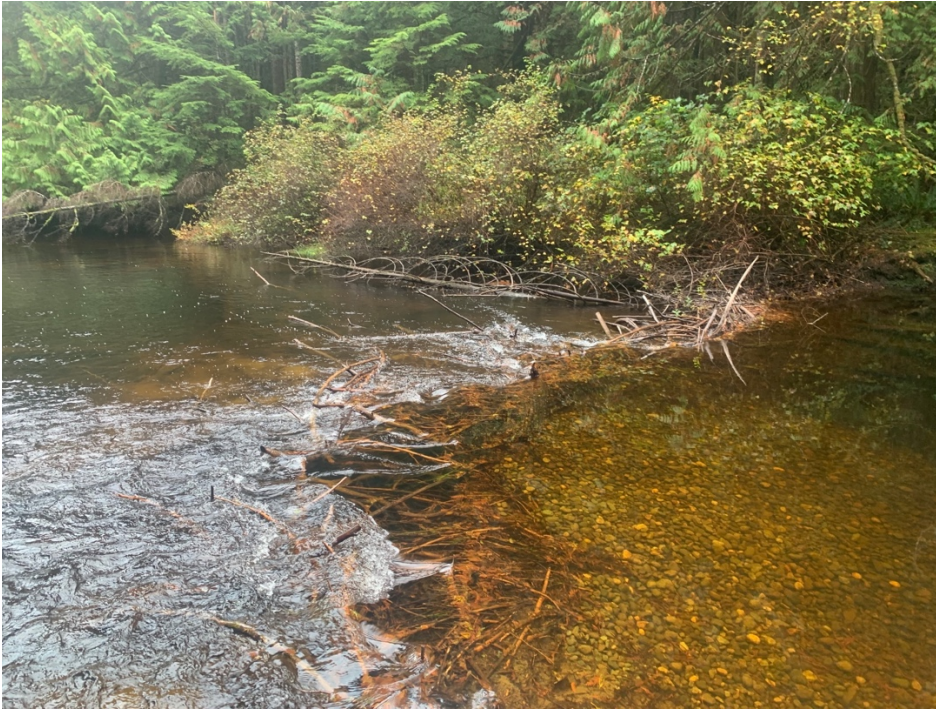
Photo 8 – Gravel placement above the beaver dam, excavated in some areas.

-Redds noted in various parts of stream. Often where gravel placement occurred.

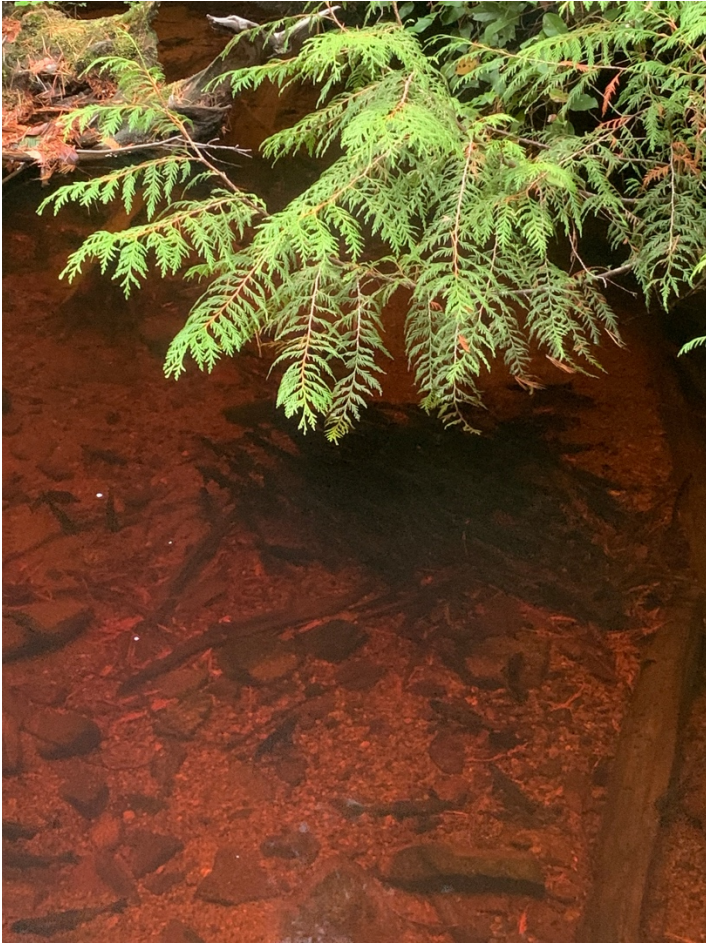
Photo 9 – Minihumps congregating below a cedar bough.

- Increase in numbers of minihumps spawning.
 - Minihumps spawning throughout areas with spawning gravels.
 - Multiple deep, dark areas where it was difficult to count schools of minihumps.
-

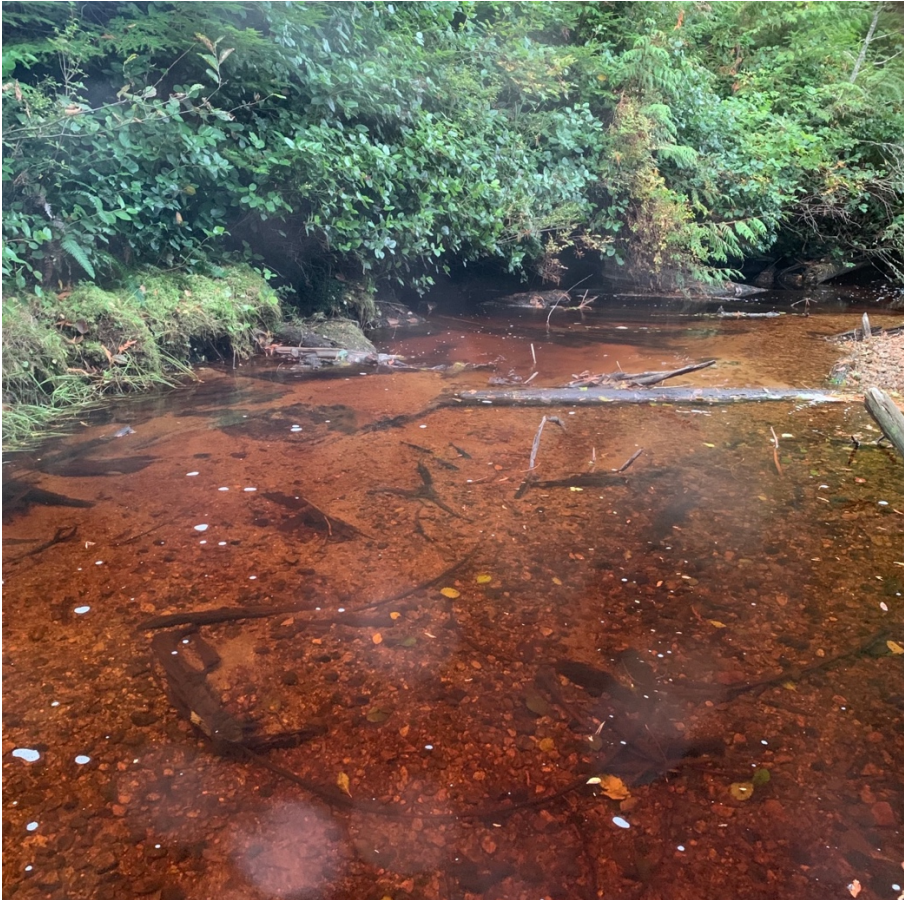
Photo 10 – Minihumps in the lower portion of Connector creek, seen to the left and down from the horizontal log in photo.

- Minihumps seen spawning where creek and lake meet.
- Minihumps noted as larger in body size than those of Minihump Creek.

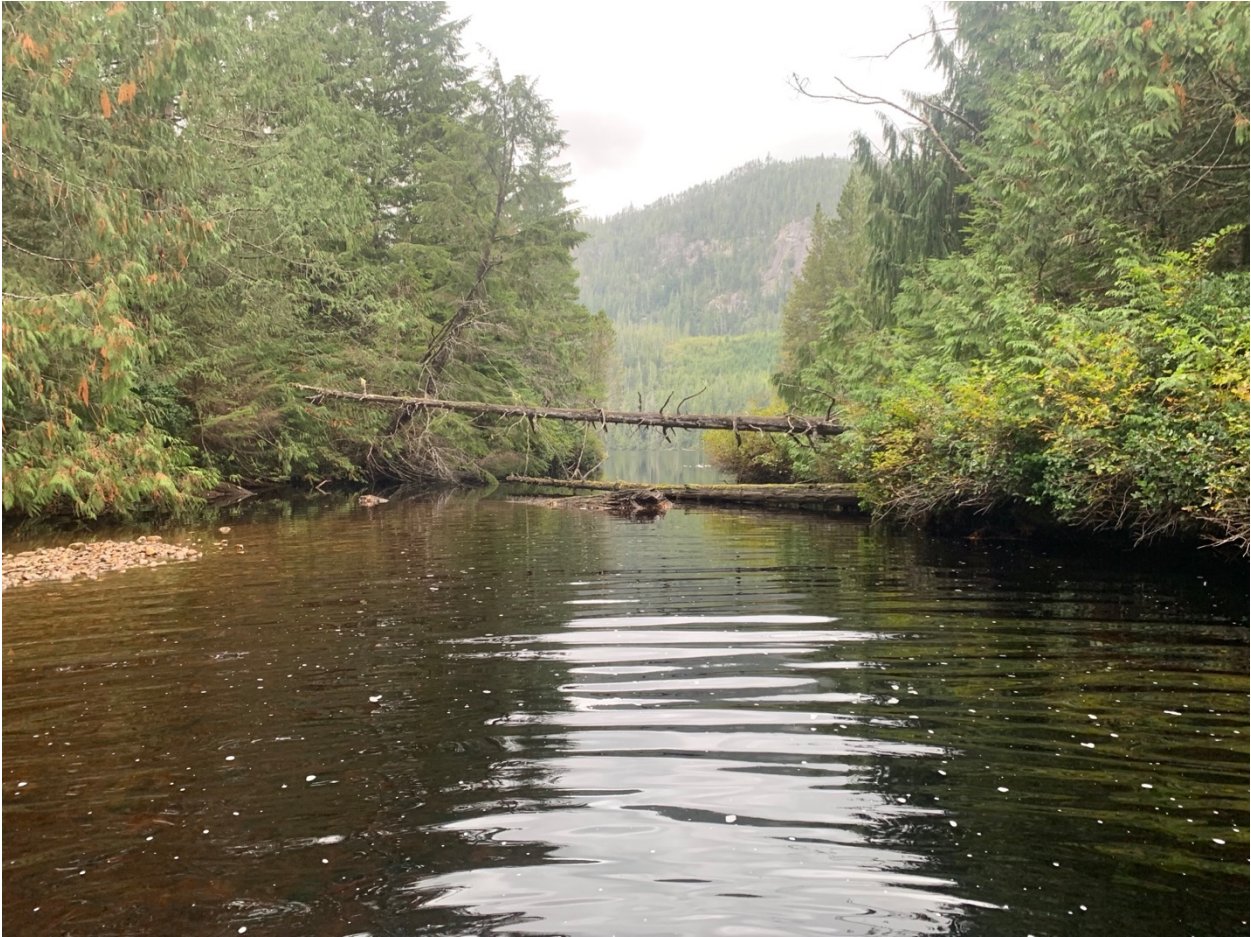
Photo 11 – Lower Loose Lake Creek where the stream meets Loose Lake.

-No fish seen in system.
