Mainland Enhancement of Salmonoid Species Society

M.E.S.S.S. Report - Rotation 4
DFO Area 12 Stock Assessment 2023

Enumeration Period: September 19-22, 2023

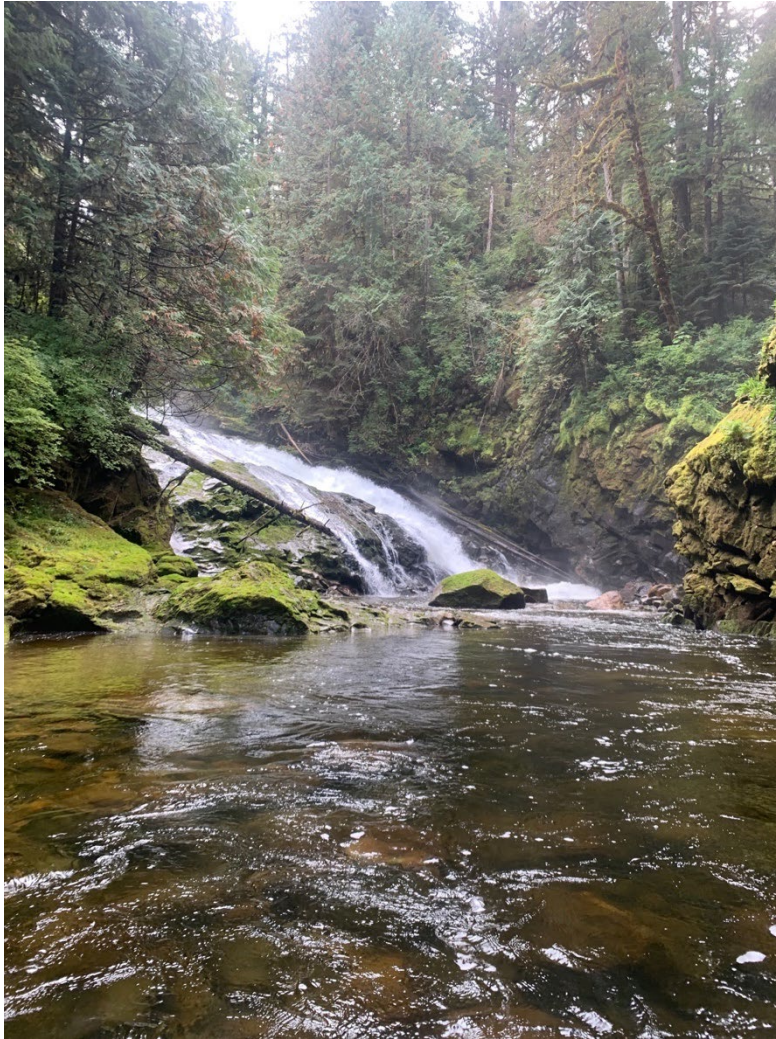
Photo 1 – Water levels at the Ahta falls.

- Water level increase made for more difficult counting conditions.
- Increases in numbers of fish seen in holding pools and spawning compared to last rotation.
- Redds and fish actively spawning in entirety of suitable spawning area.
- Large amount of grizzly bear tracks and fish filled scats around stream.

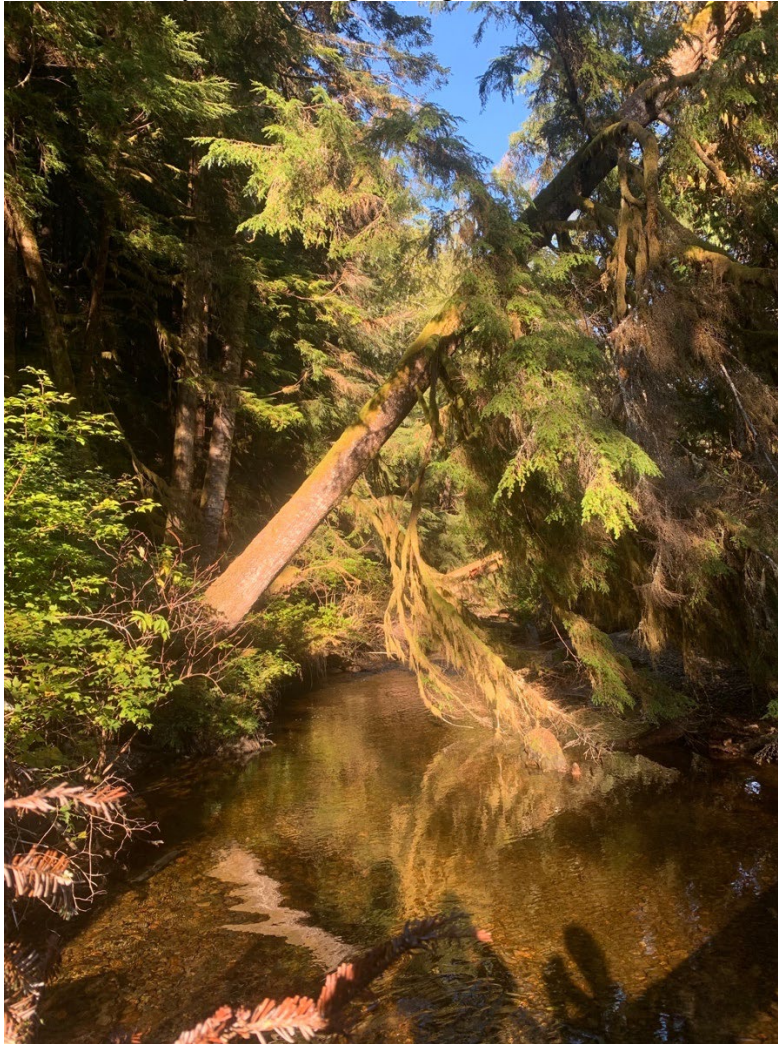
Photo 2 – A stretch of Viner Creek that had chums actively spawning.

- Continued observation of pinks spawning, increase in chums spawning and expansion of spawning to new areas.
 - Fish seen distributed through lower 500m of stream
-

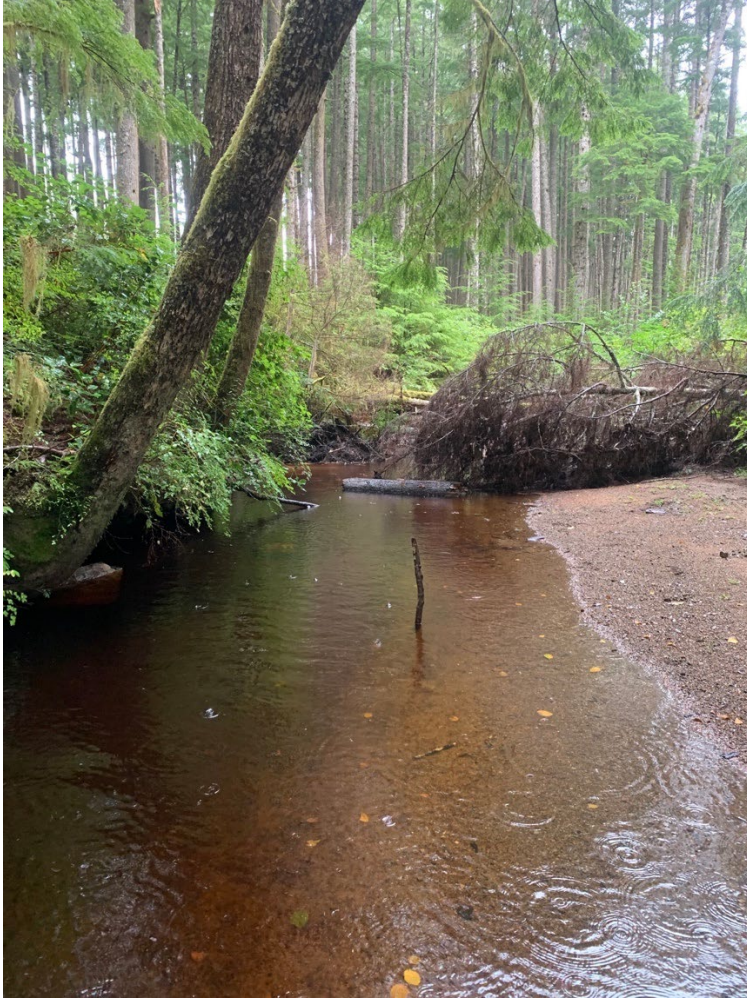
Photo 3- Changes in flow in Shoal Harbour creek, stick marking stream levels before rain.

- Good visibility in stream.
 - Majority of fish seen in lower 200m, but actively trying to move upstream.
-

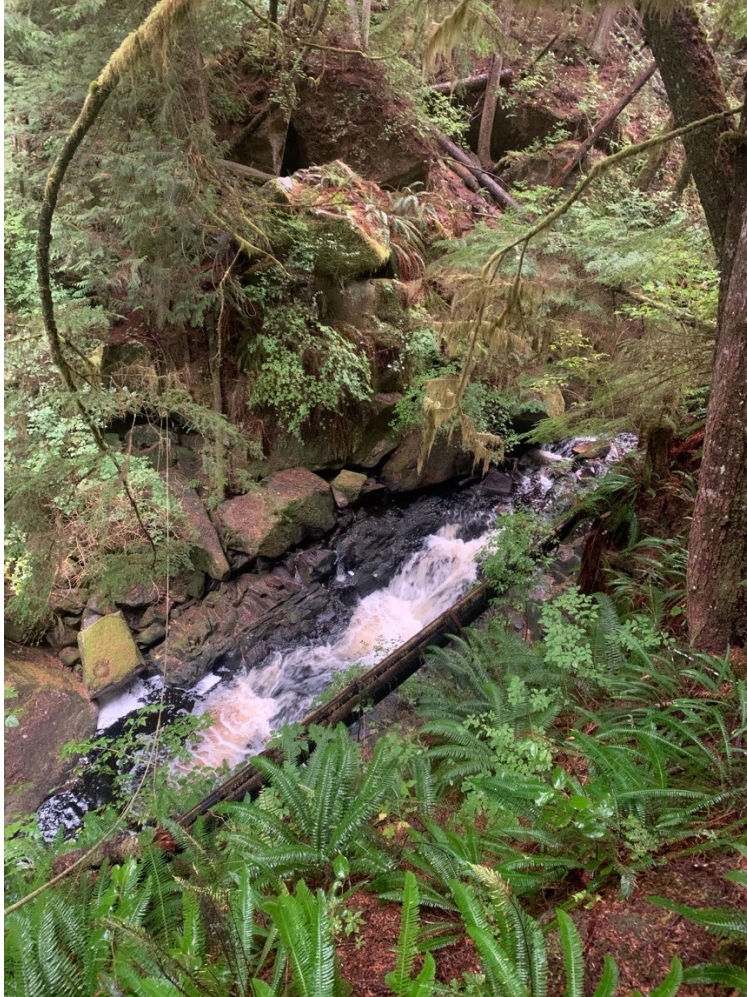
Photo 4 – Water levels at the lower falls on Scott Cove creek, same location where 20 min jumper survey occurs.

- Three jumpers noted at lower falls.
 - 35 coho seen jumping at 1.5km falls during 20 min survey.
 - Notes: Scott Cove surveys are more beneficial for presence/absence data than population estimates because of how little of the system we are able to survey. Our numbers are largely based on jumper counts. Carrington Bridge was also assessed.
-

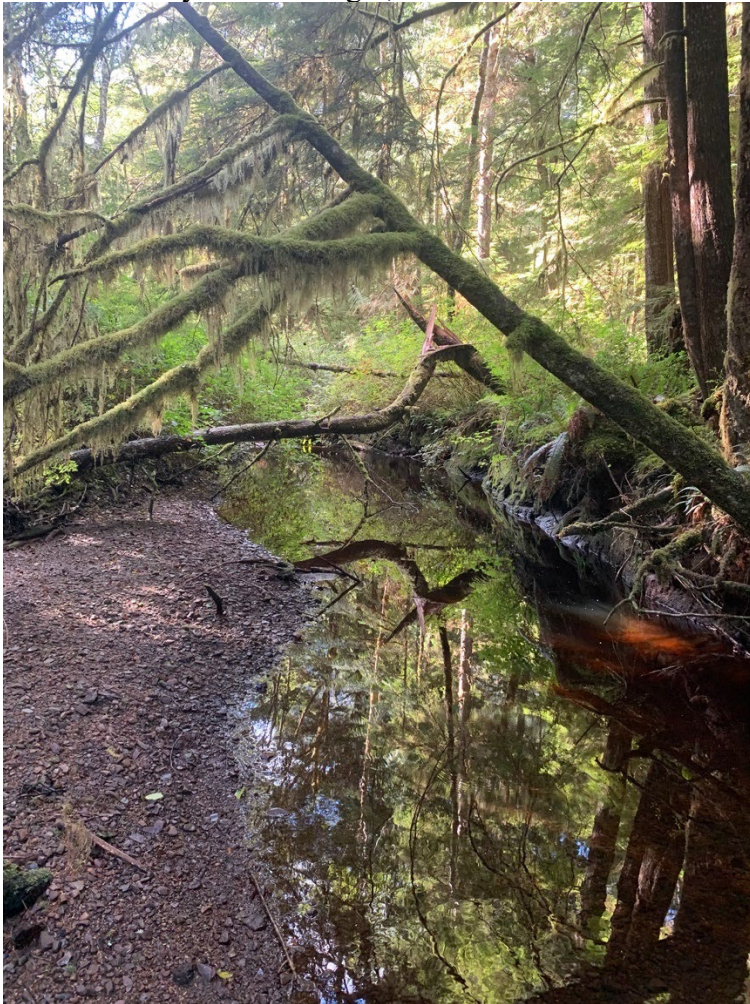
Photo 5 – Water levels on the middle section of Wahkana creek.

- Improved water levels but still very slow moving.
 - Fry seen.
-

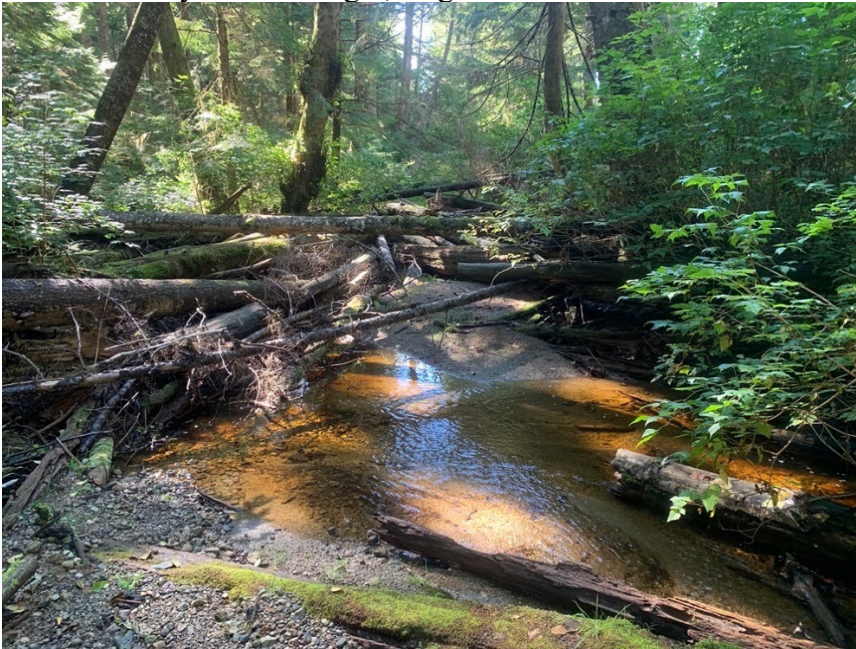
Photo 6 – Improved flows seen on Maple creek.

- First count with fish seen.
 - Majority of pinks were hiding in woody areas or under riffles.
-

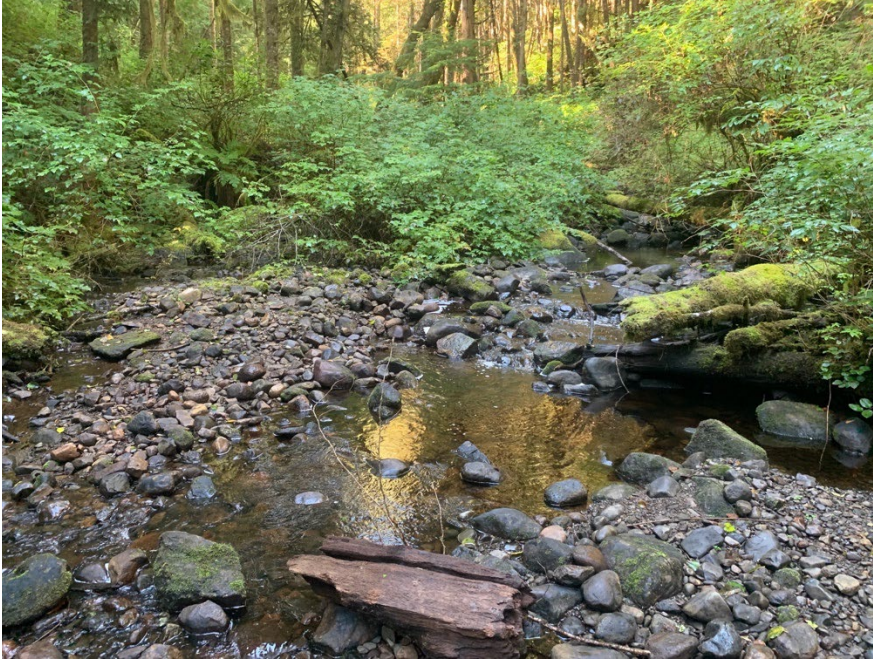
Photo 7 – Flow connectivity restored at Carriden creek

- 1 dead cutthroat trout found.
 - Increased flow due to recent rains.
 - Precipitation within 24hrs of survey.
-

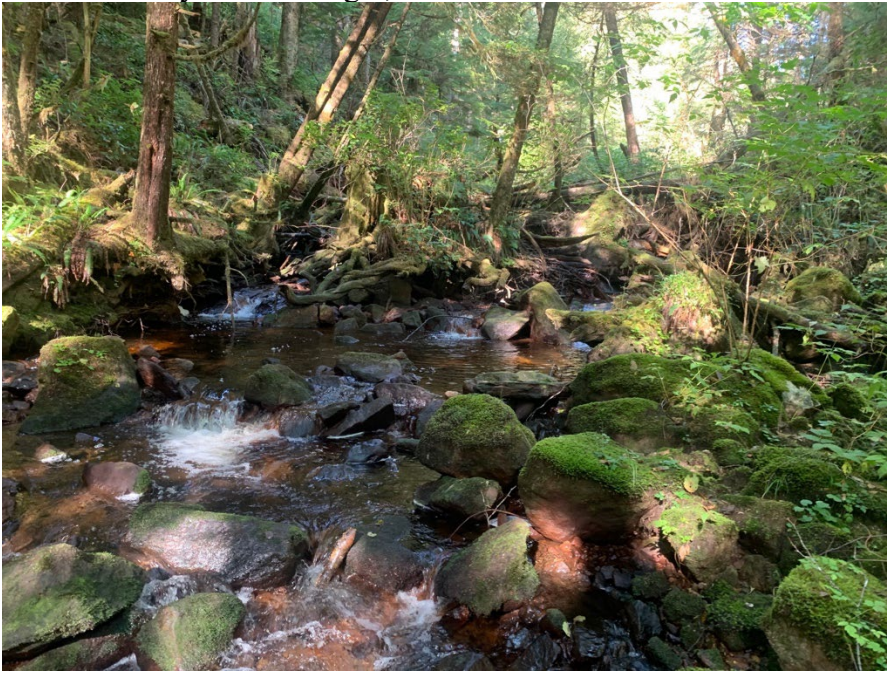
Photo 8 – Step pool section of Simoom Sound creek.

- Cutthroat trout seen in first 200m of stream.
- Stream temperature and dissolved oxygen levels very conducive to spawning and salmon rearing.
